Subjects: Dock and Sea Trials "RTA 1" Catamaran Passenger Ferry
Metal Shark Franklin, LA.

The following was observed during my visit of April 27, 2018

First Catamaran Ferry "RTA 1"

Two (2) 32.0 (m) X 7.7 (m) X 1.35(m)RTA Passenger Ferries

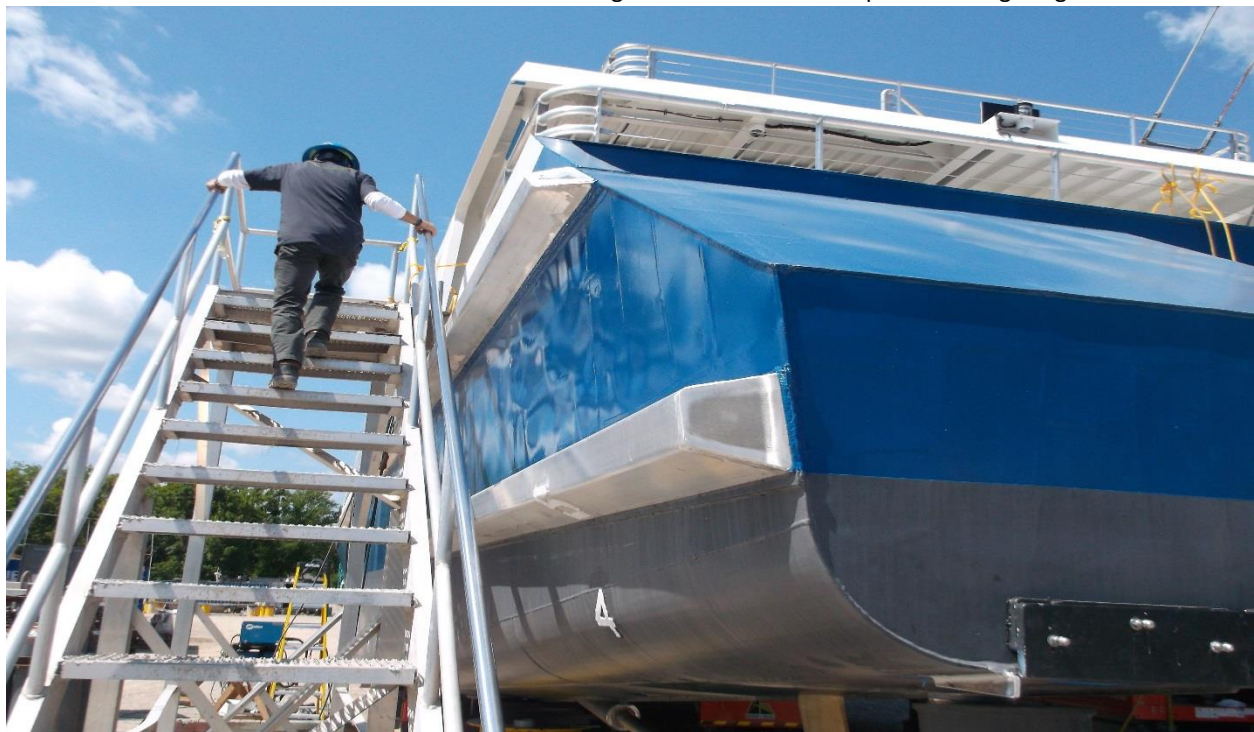
First Catamaran Ferry "RTA 1": The areas having the majority of the deflection/distortion in the shell plating were observed internally with areas between longitudinal members, near bulkheads and piping appendages found to have some distortion noted. There was no notable

deformation noted to the internal members but some small gaps were noted on the starboard forward between the side shell plating and longitudinal members.

Aft portside view of hull shell plating with deflection/distortion

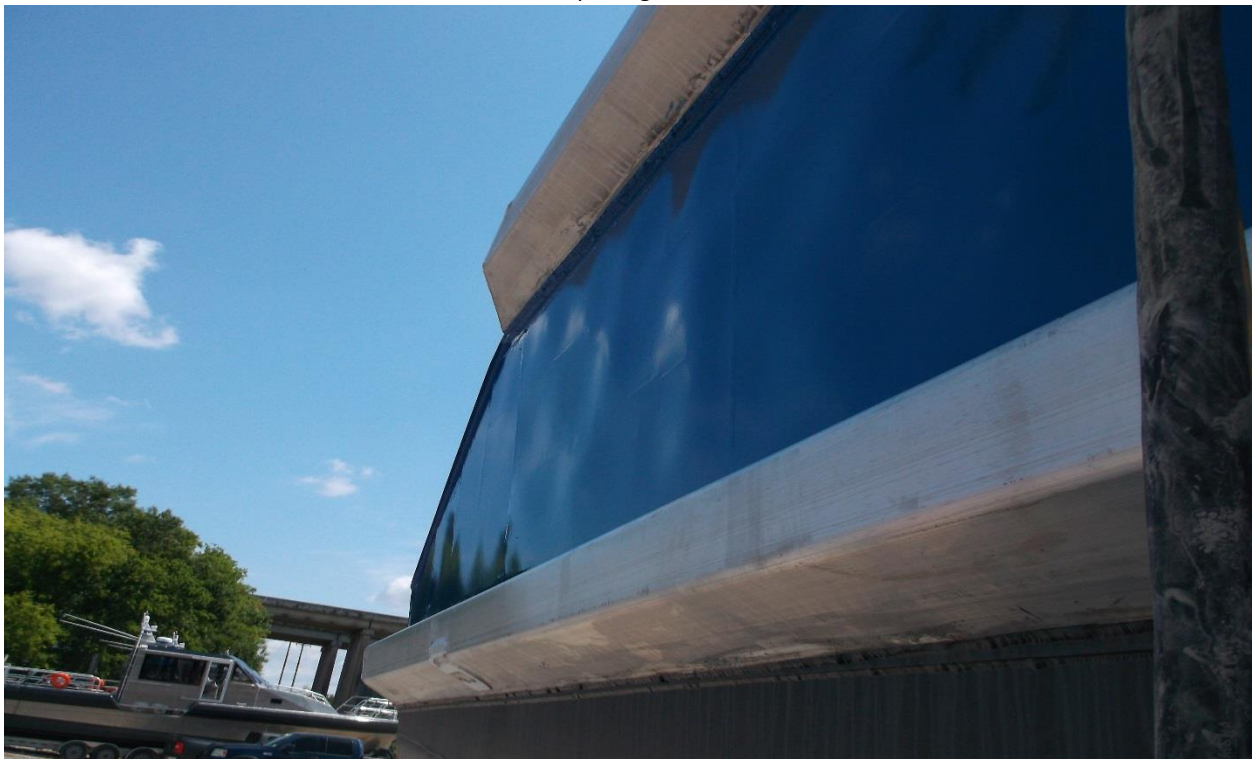
Stern starboard side shell plating deflection/distortion

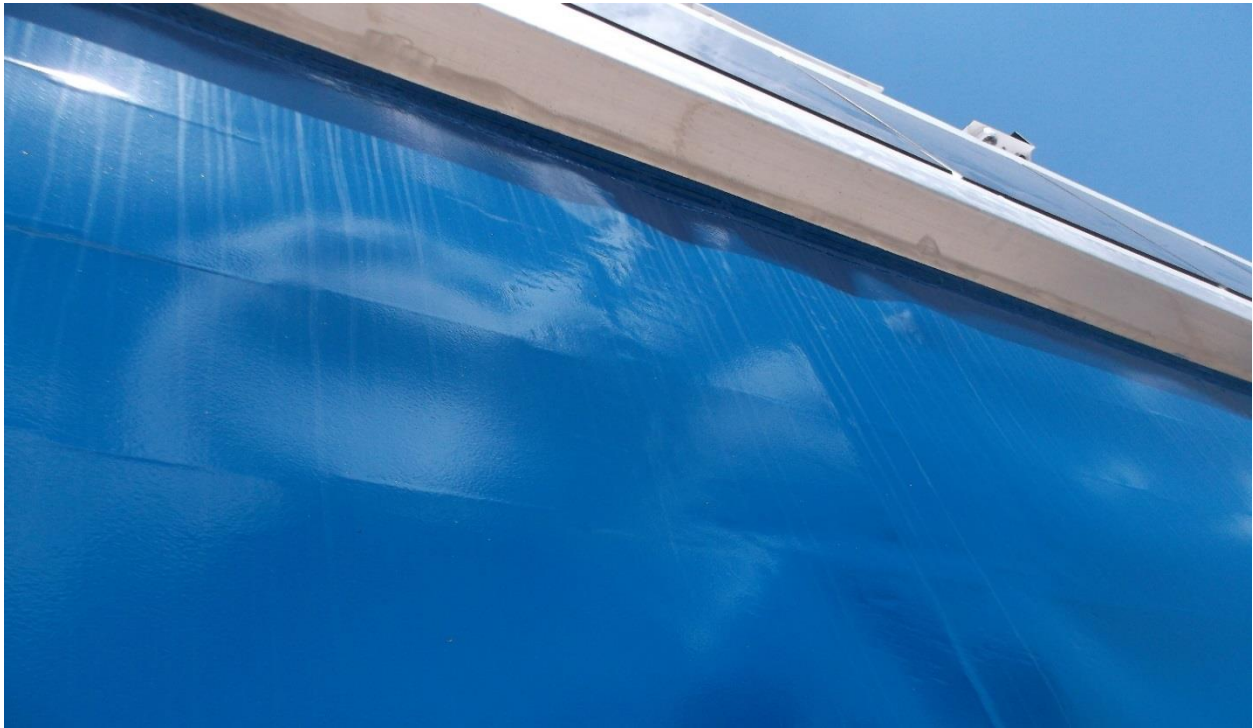
Starboard mid-ship areas of shell plating deflection/distortion

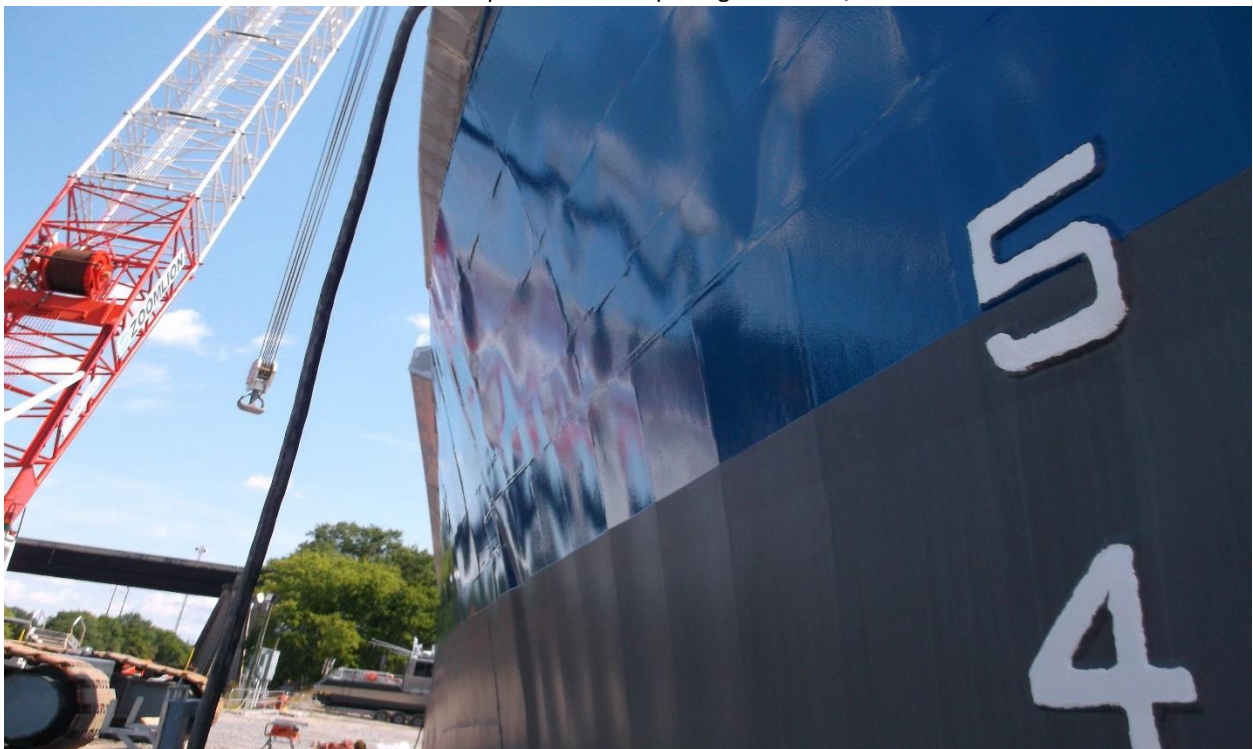
View of starboard bow deflection/distortion looking aft

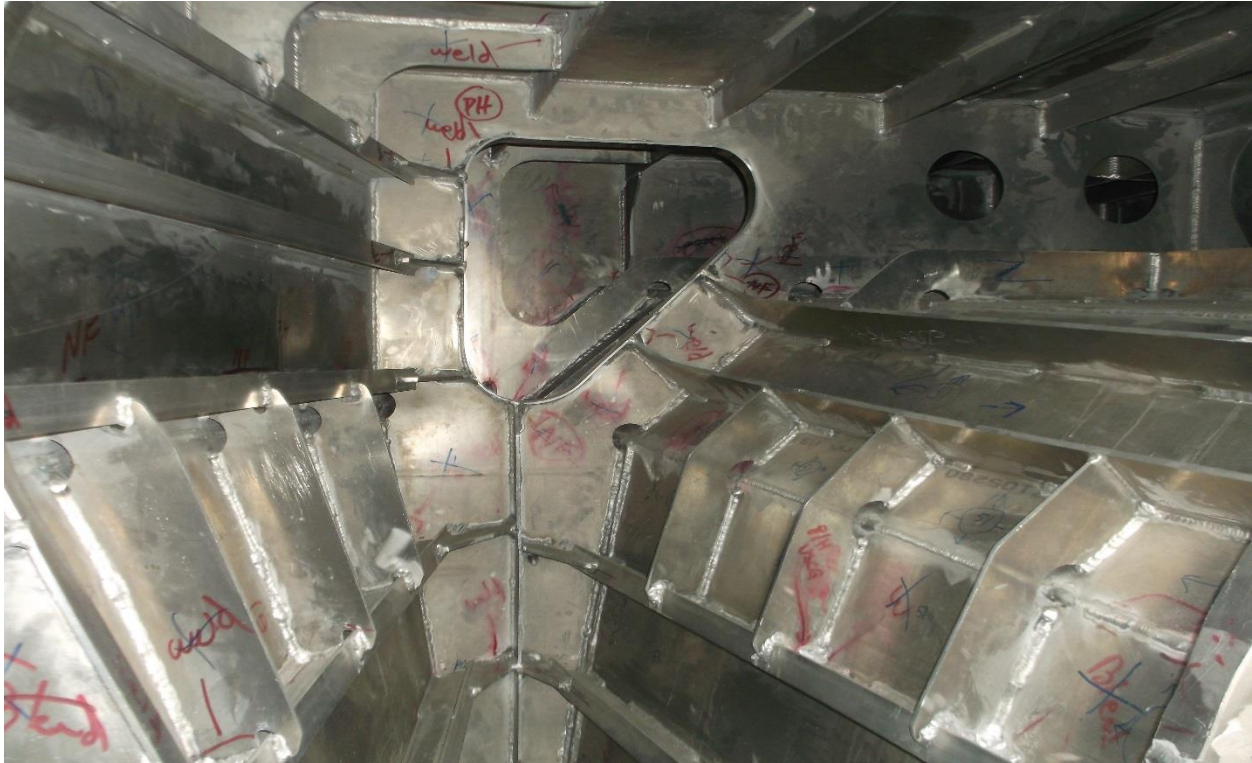
The forepeak voids were entered (upper areas only accessible) and internal structure observed. The fuel oil fill and vent through piping is mounted inboard longitudinally and inboard transversely leading to forward center fueling station. See discrepancies below.

View looking forward inside portside upper forepeak area

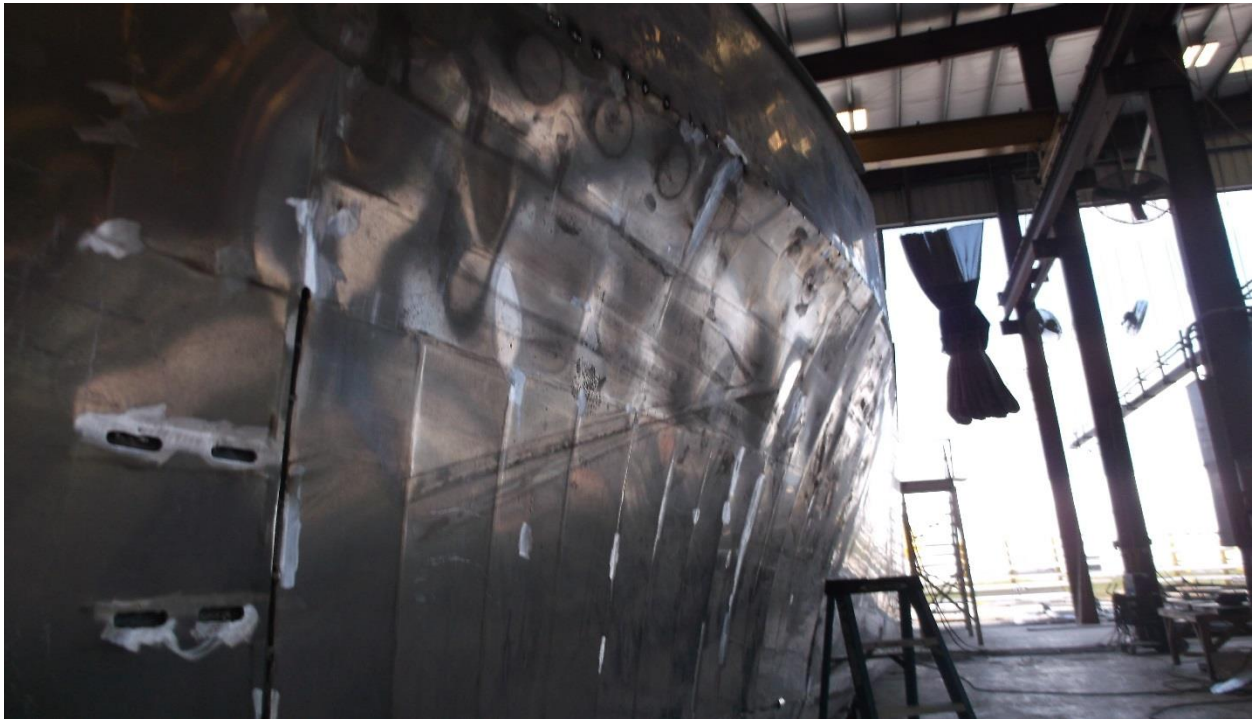
"RTA 2" forward portside hull view having some deflection/distortion

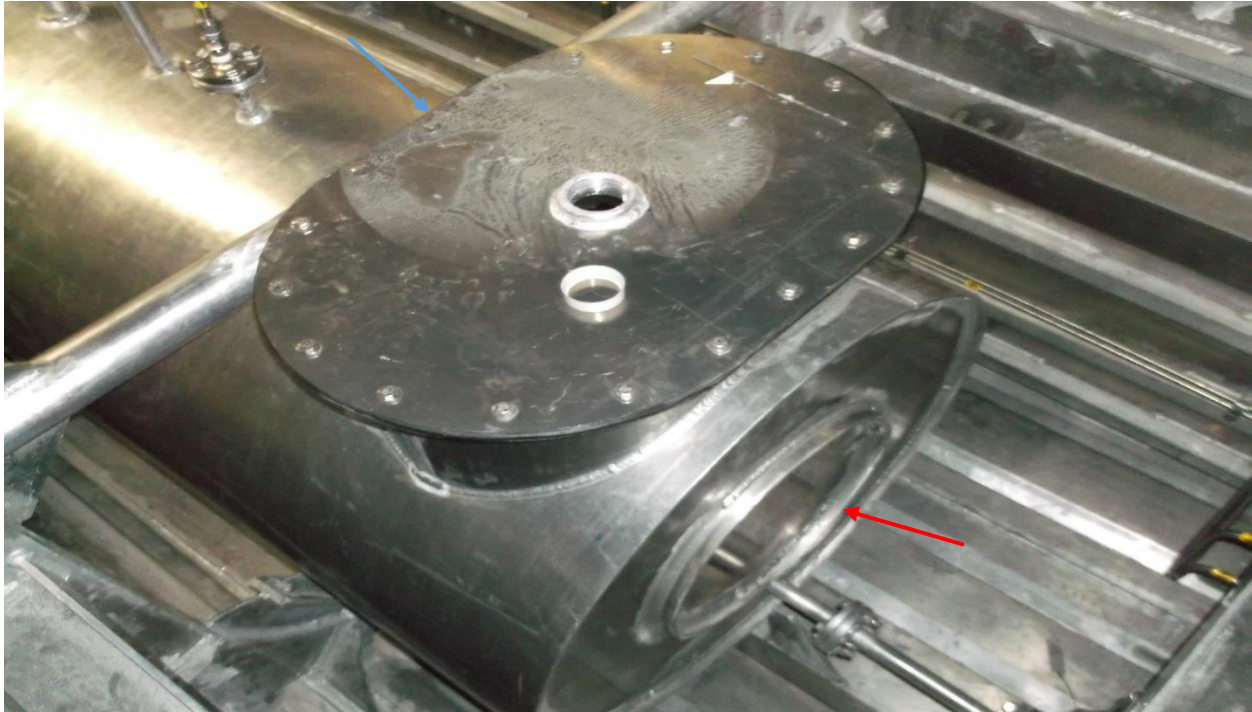
Aft side of tank, red arrow is original flange removed and blue arrow showing new larger oval bolted hatch

The fuel oil tanks having the previously installed large inspection/cleanout flanges removed from the ends with insert plates installing in accordance with USCG requirements. The single top side oval bolted flange/ access/cleanouts were observed installed into each tank ready for welding.

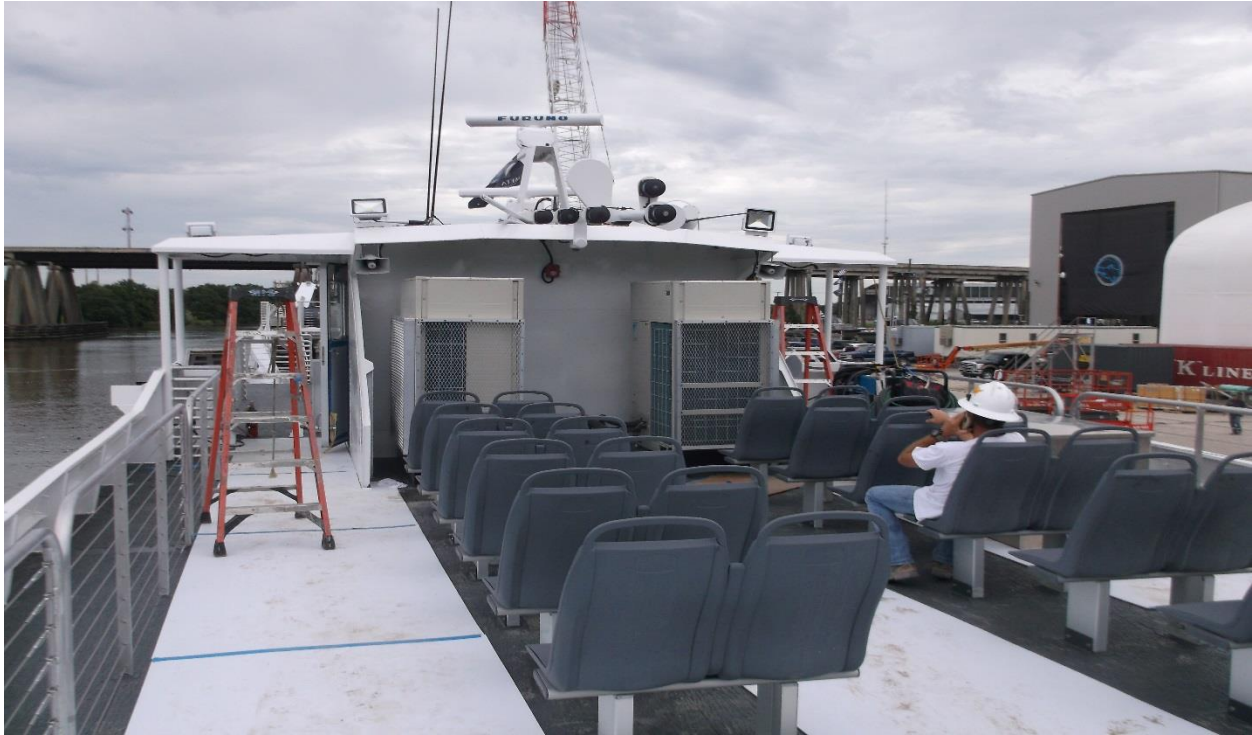
Upper deck areas were observed with concerns for the two large HVAC condenser units noise level during operations, exposed refrigerant tubing and the need to prevent passenger access in this area. Metal Shark will add guards with use of expanded metal and/or chains with signage to prevent access. Seating arrangement was discussed with all seating foundations installed facing forward.

Upper deck having seating and guards installed at sides and ends of HVAC condenser units. Above pilothouse the radar screen, VHF radio antennas and PA speakers are installed.

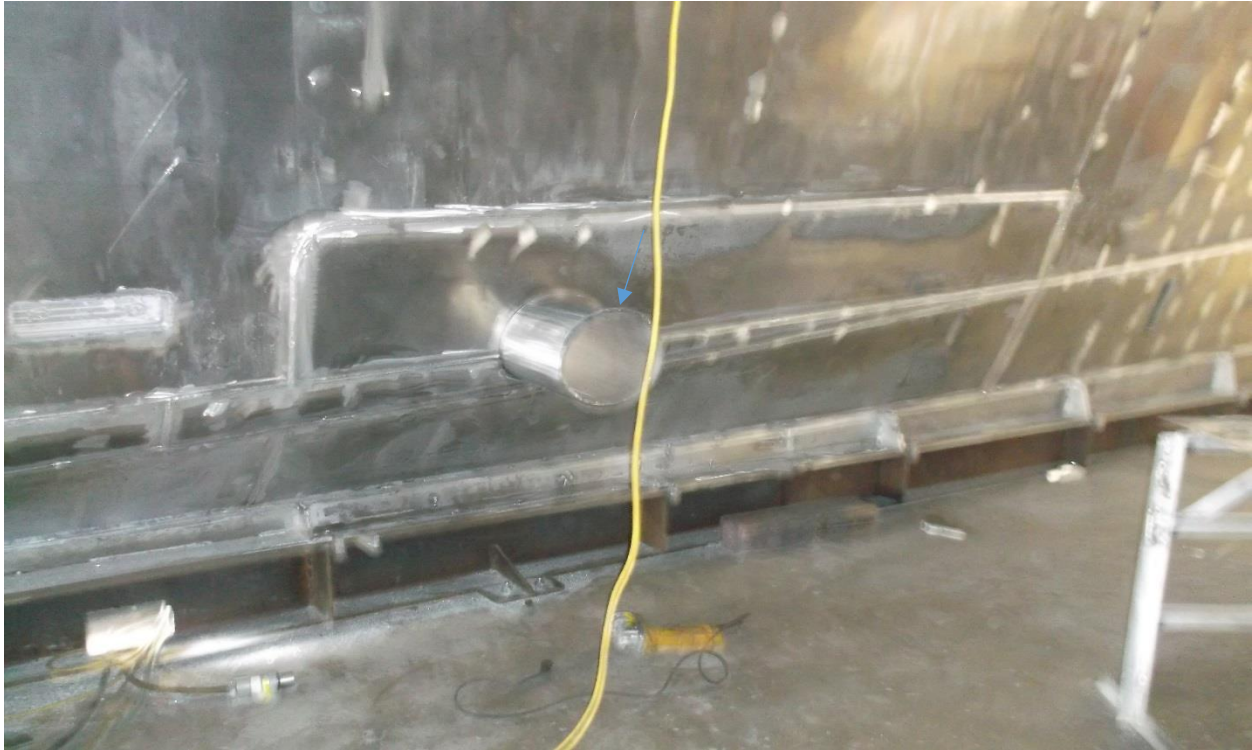
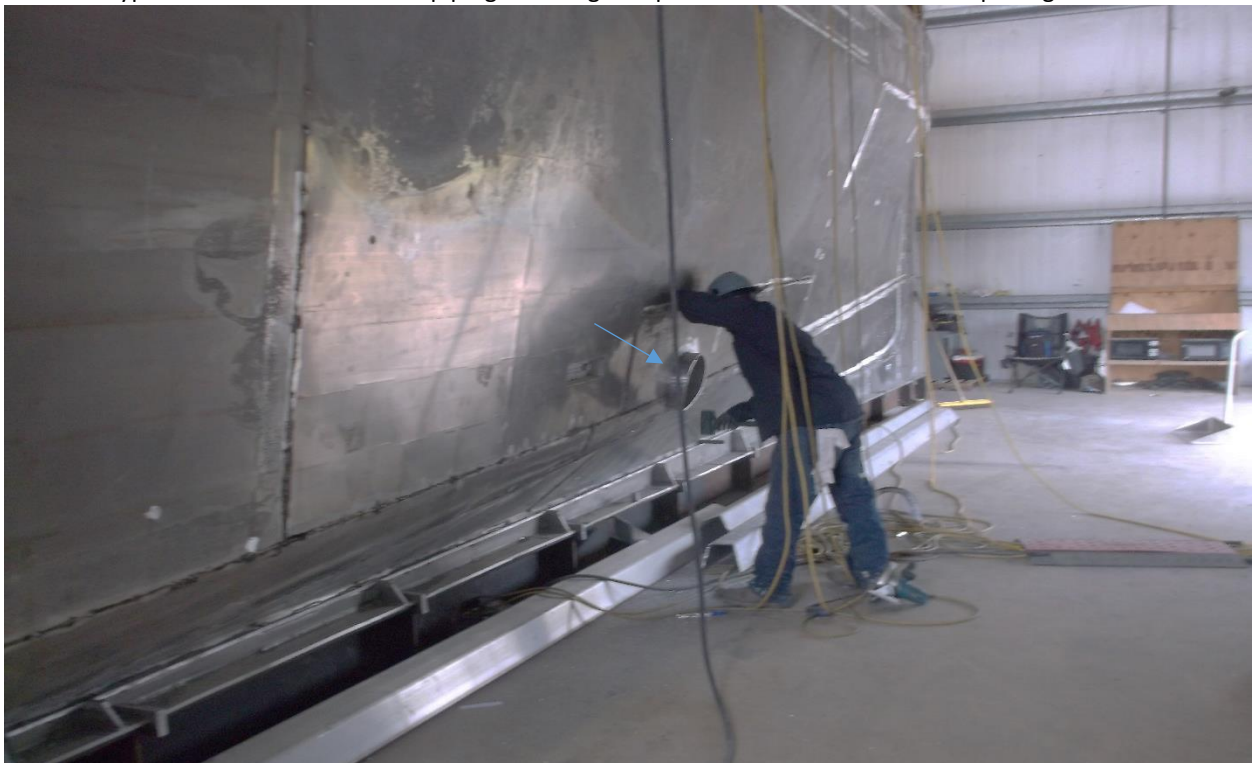
Typical views of bow thruster piping installing into port and starboard lower hull plating sections

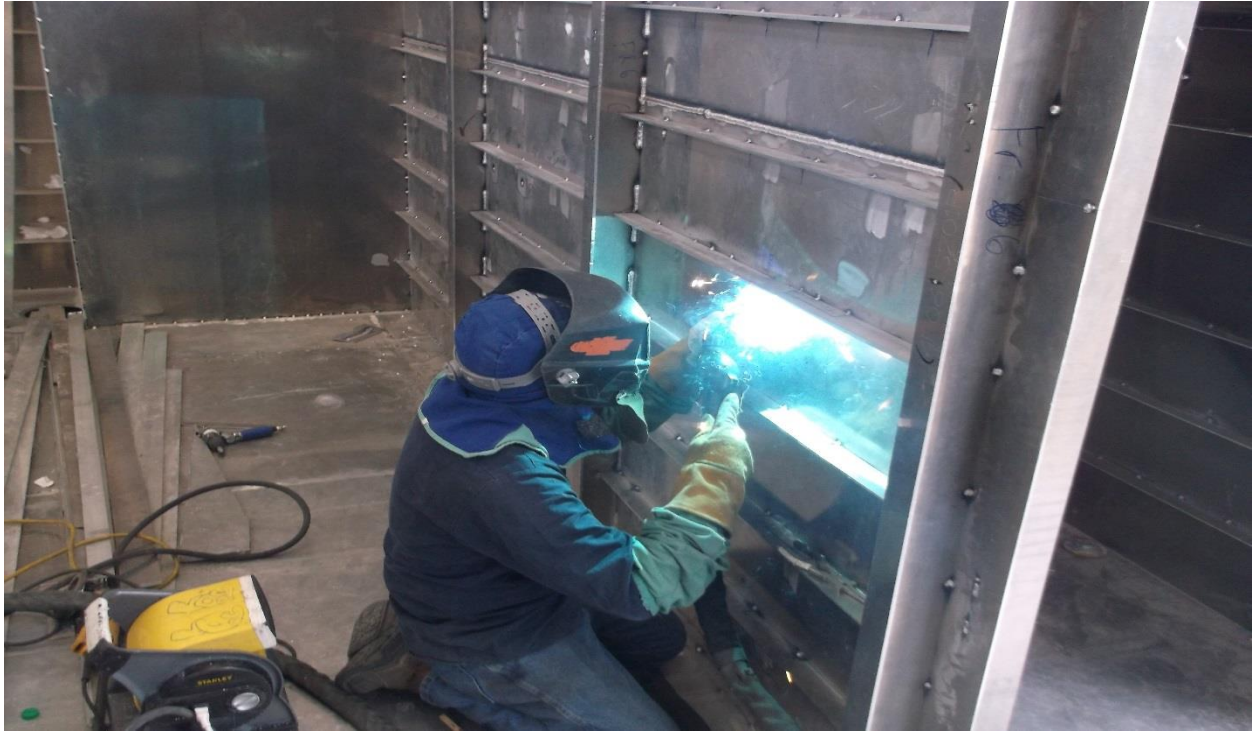
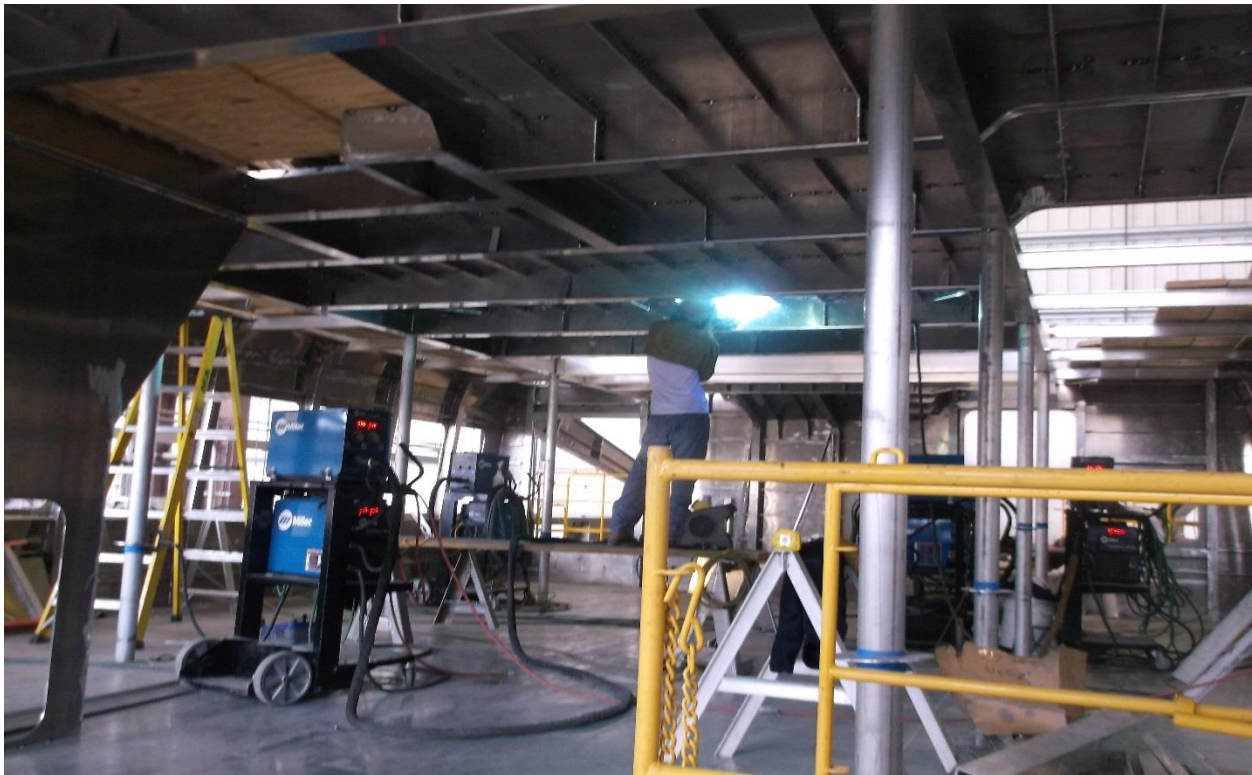
Welders working internals of aft bulkhead and forward overhead structural members of deckhouse

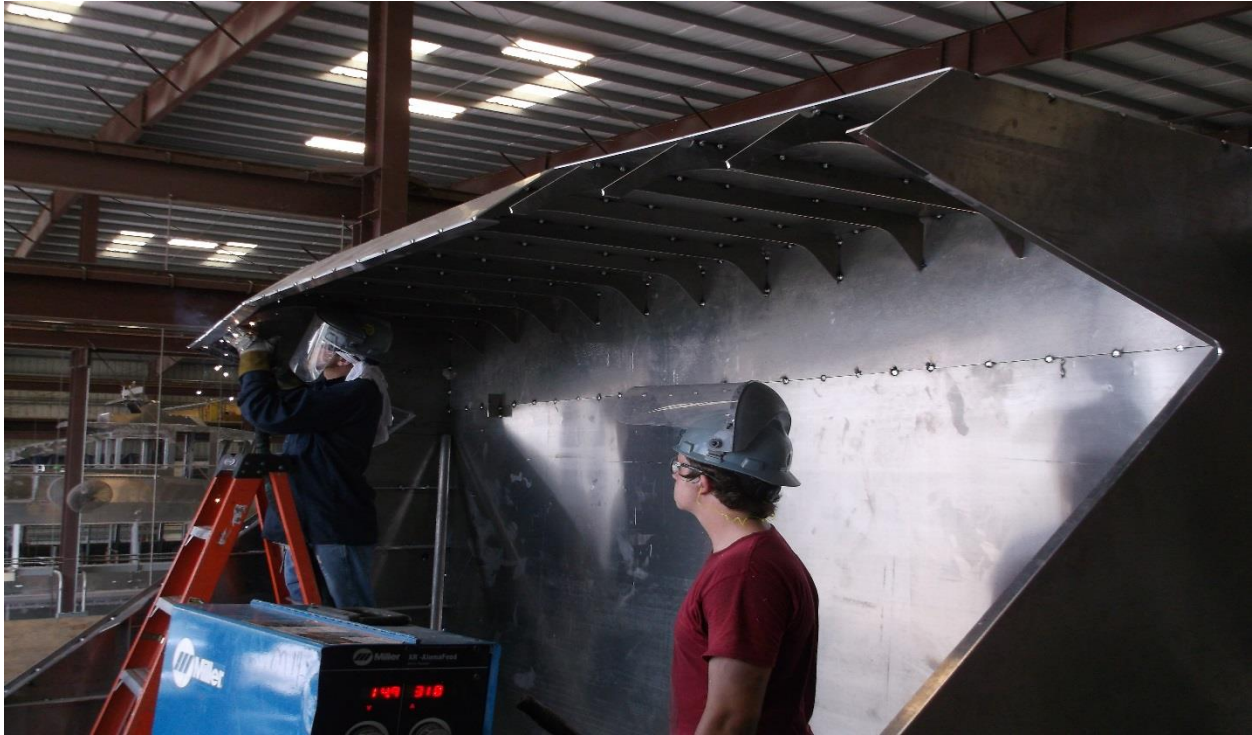
Workers installing final overhead plating sections aft of pilothouse

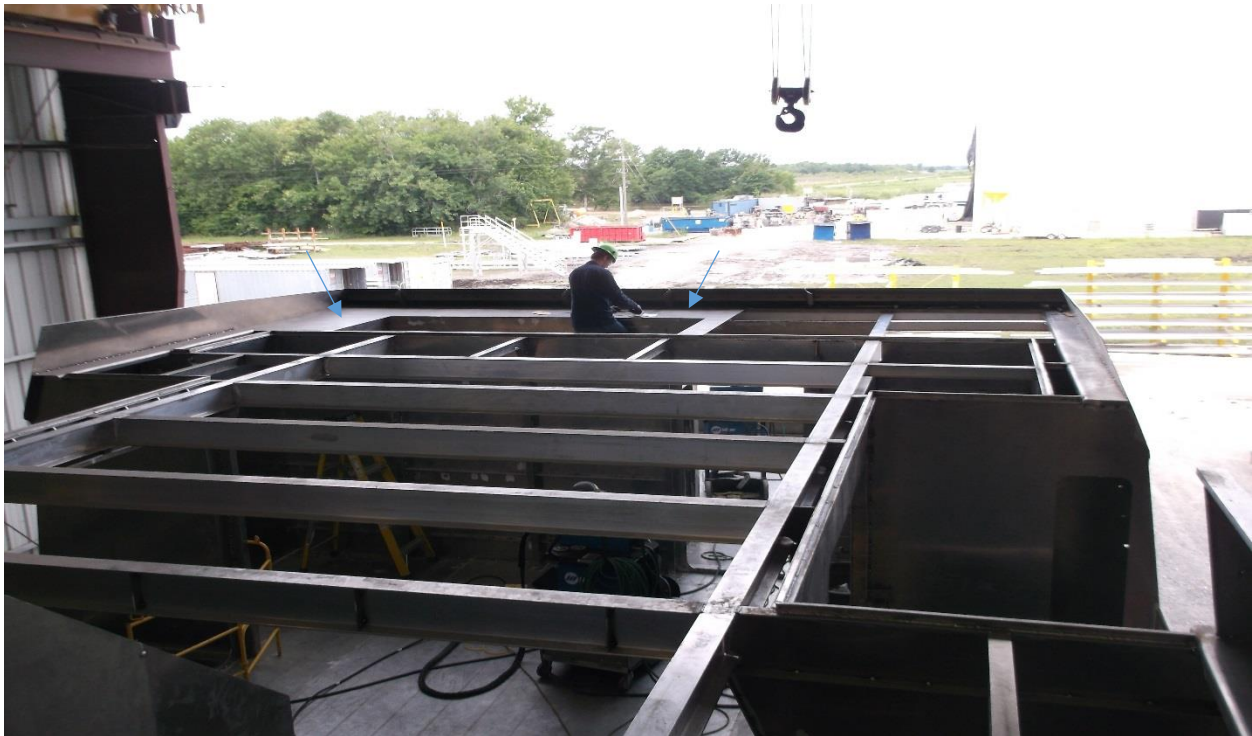
View of upper deck structural support beams with end plating starting to install

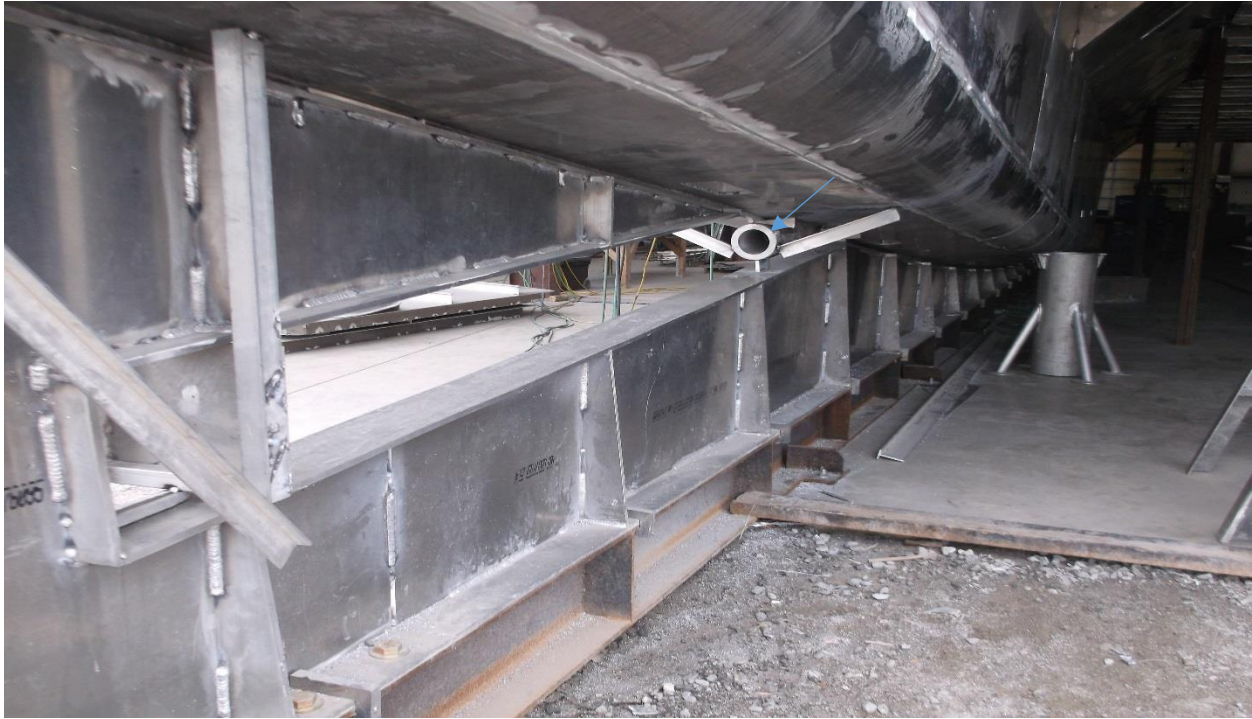
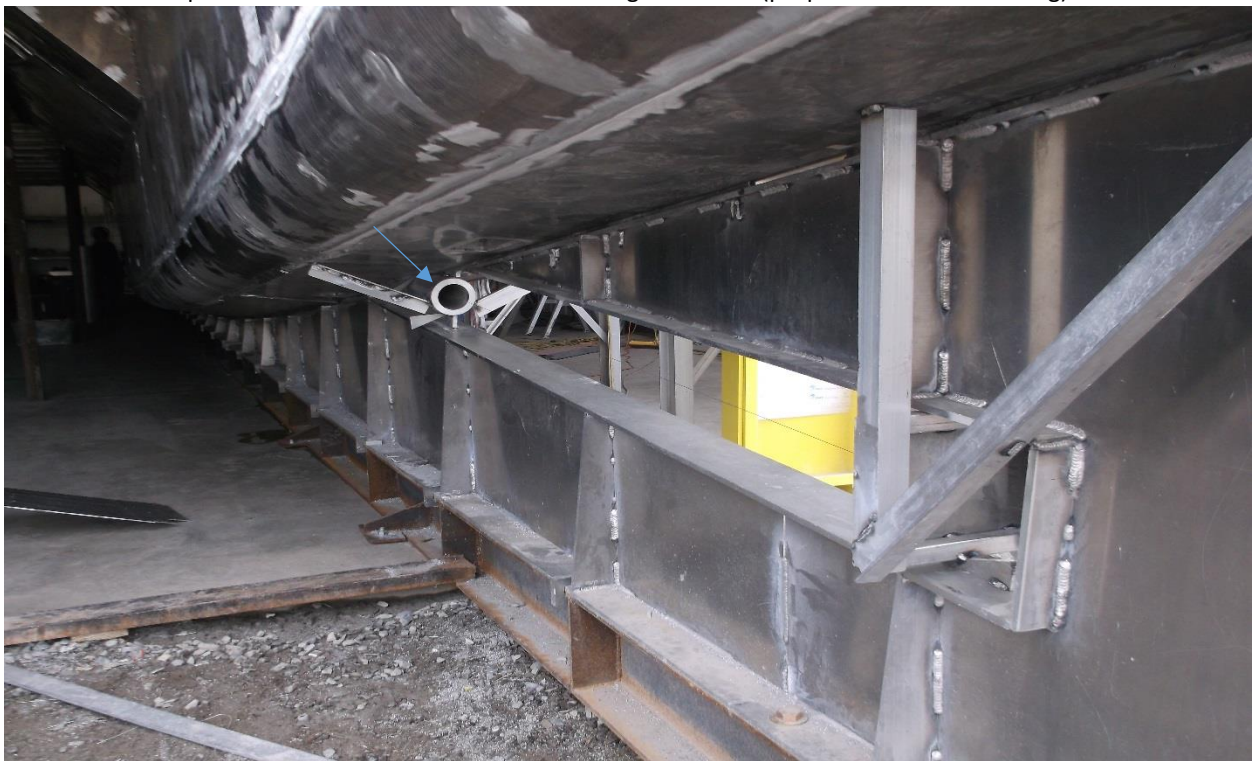
Views of port and starboard aft hull bottom having stern tubs (propeller tail shaft housing) installed

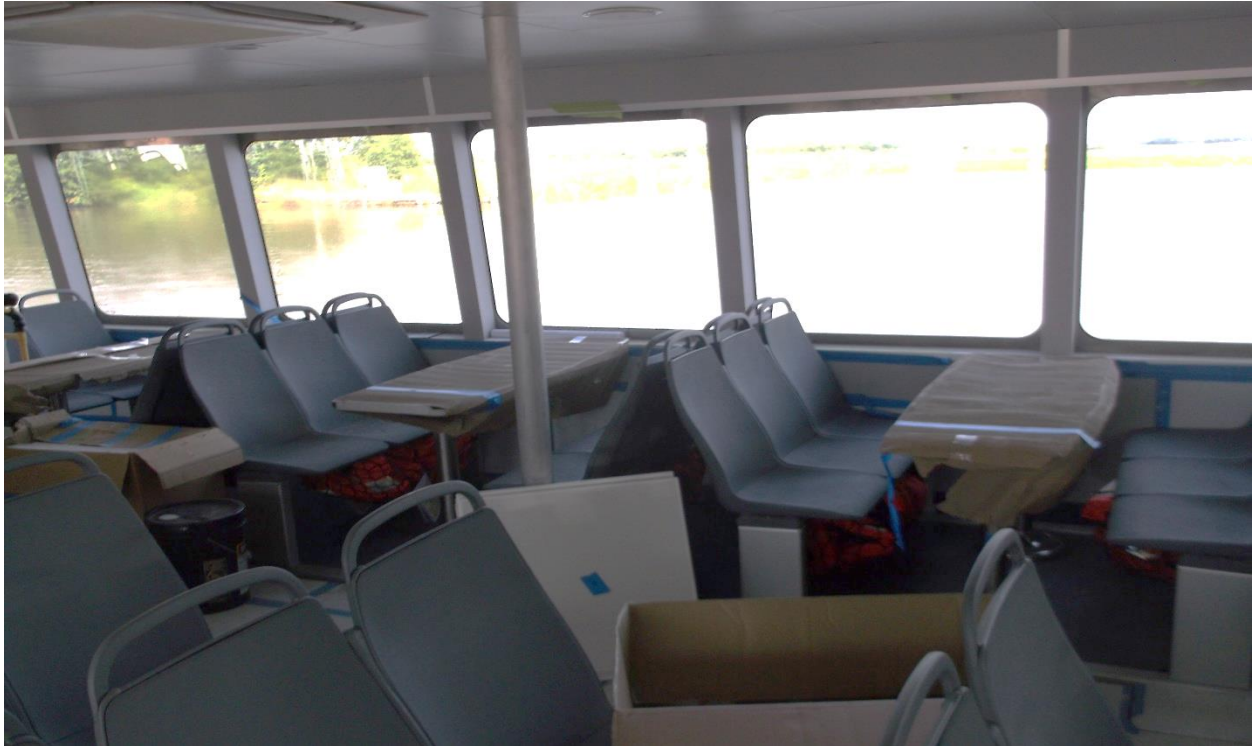
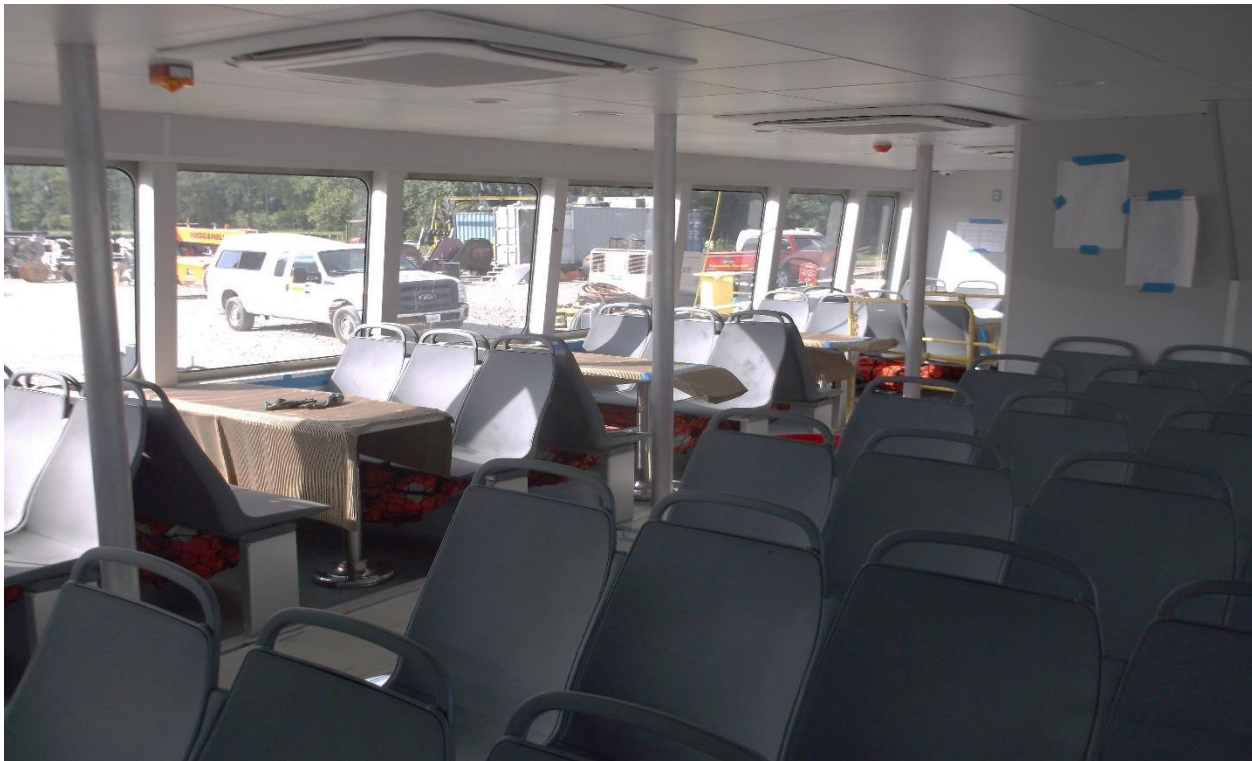
"RTA 1" views of port and starboard side fixed tables and seating in the main deckhouse 5/31/18

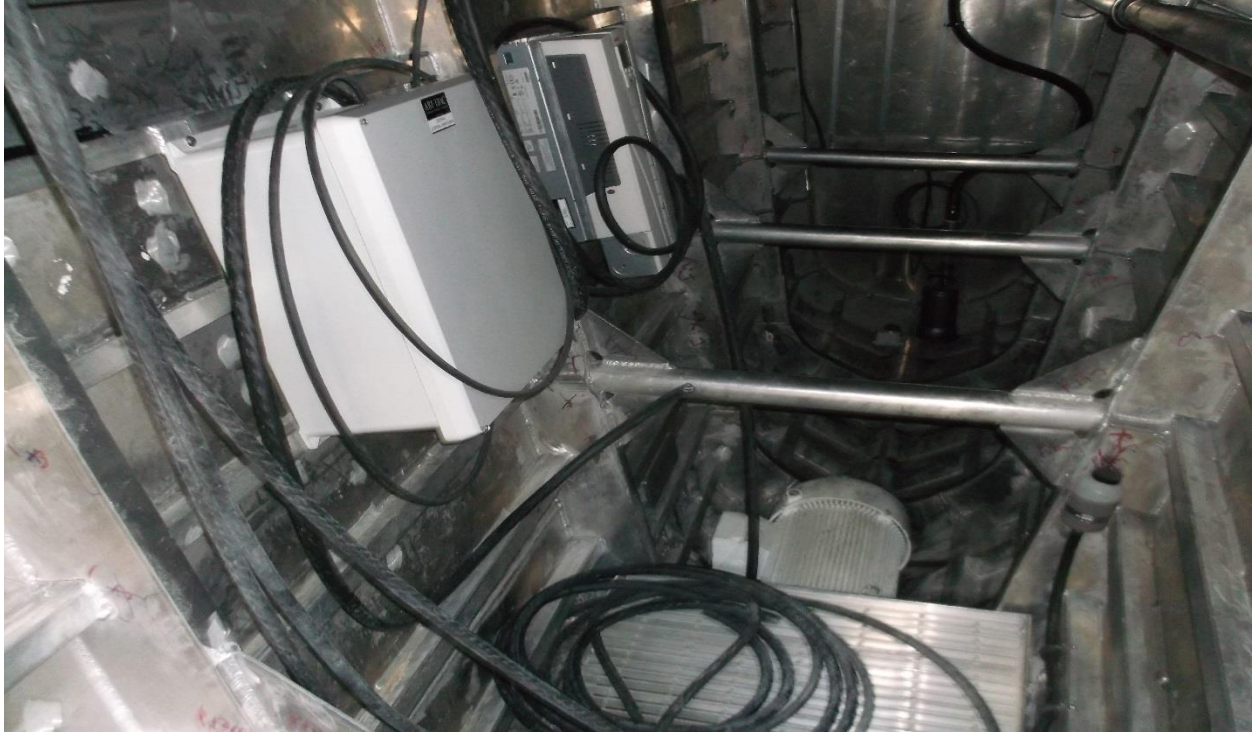
View inside no.2 starboard hull void having bow thruster control panels with electrical cables pulled ready to install

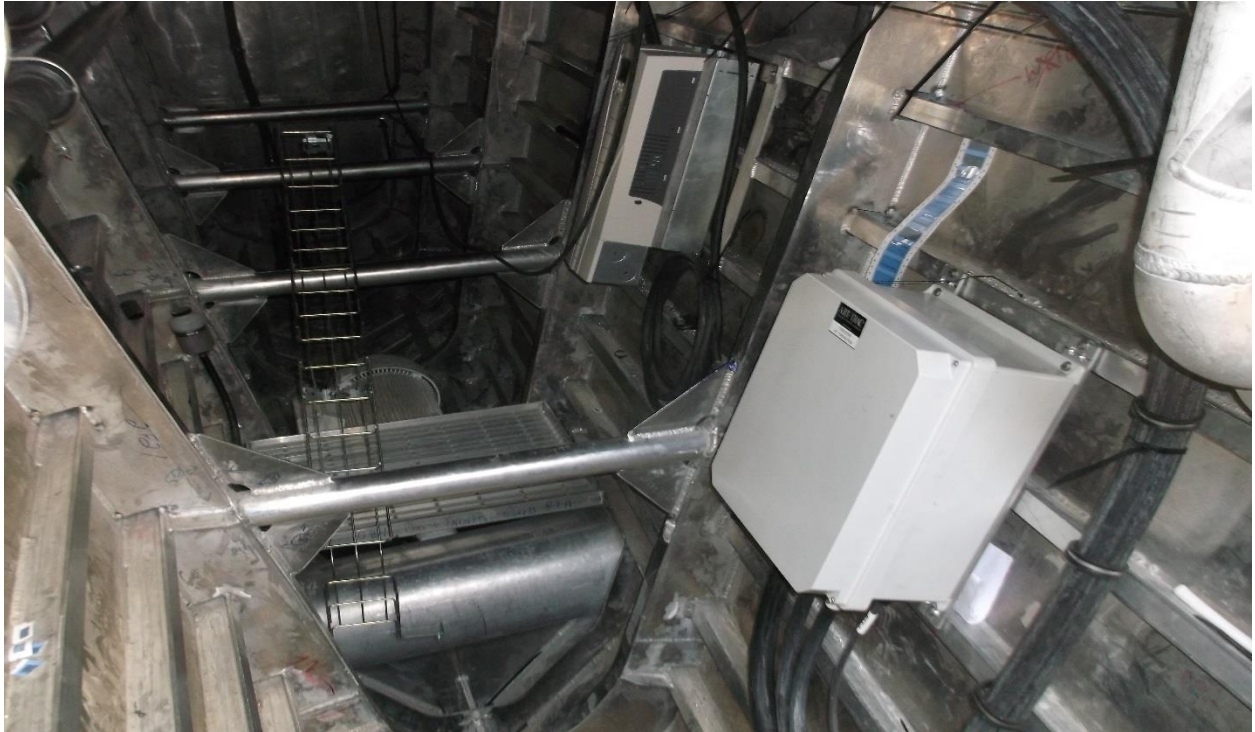
View inside no.2 port hull void having bow thruster control panels with electrical cables installed

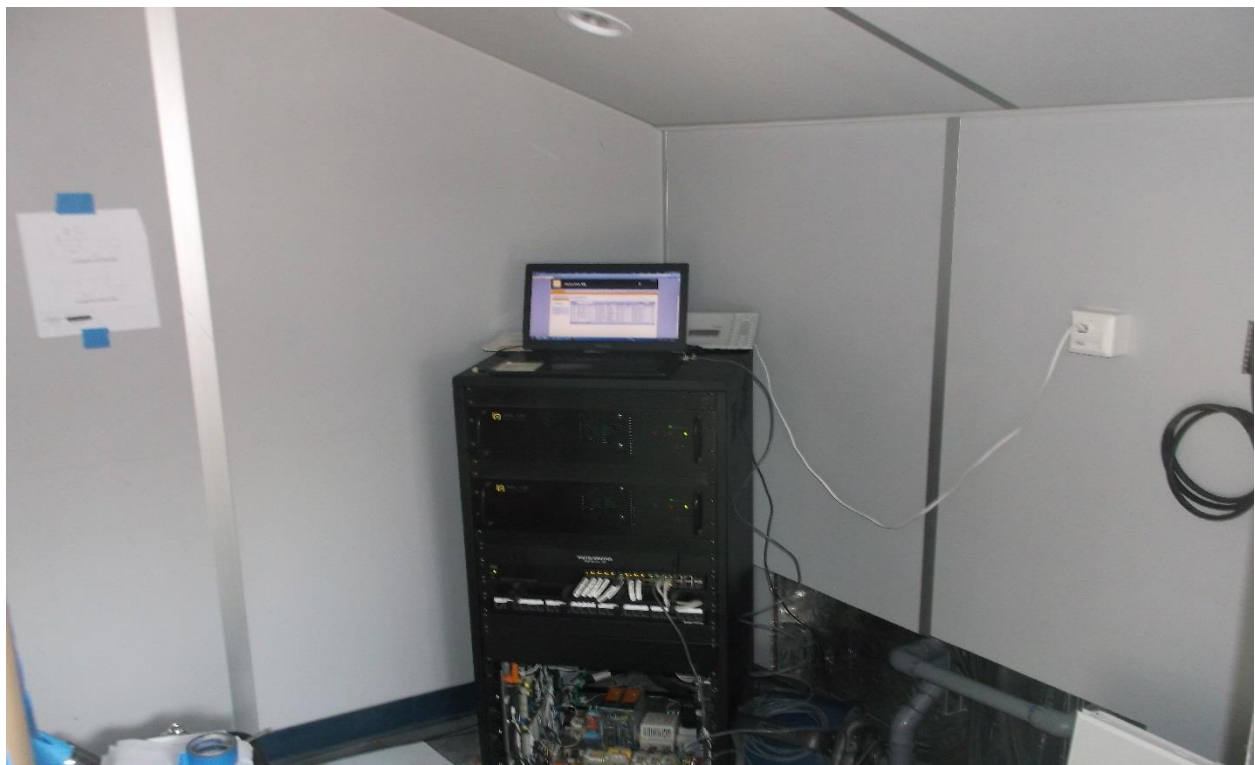
View inside crew room with electronic mainframe working

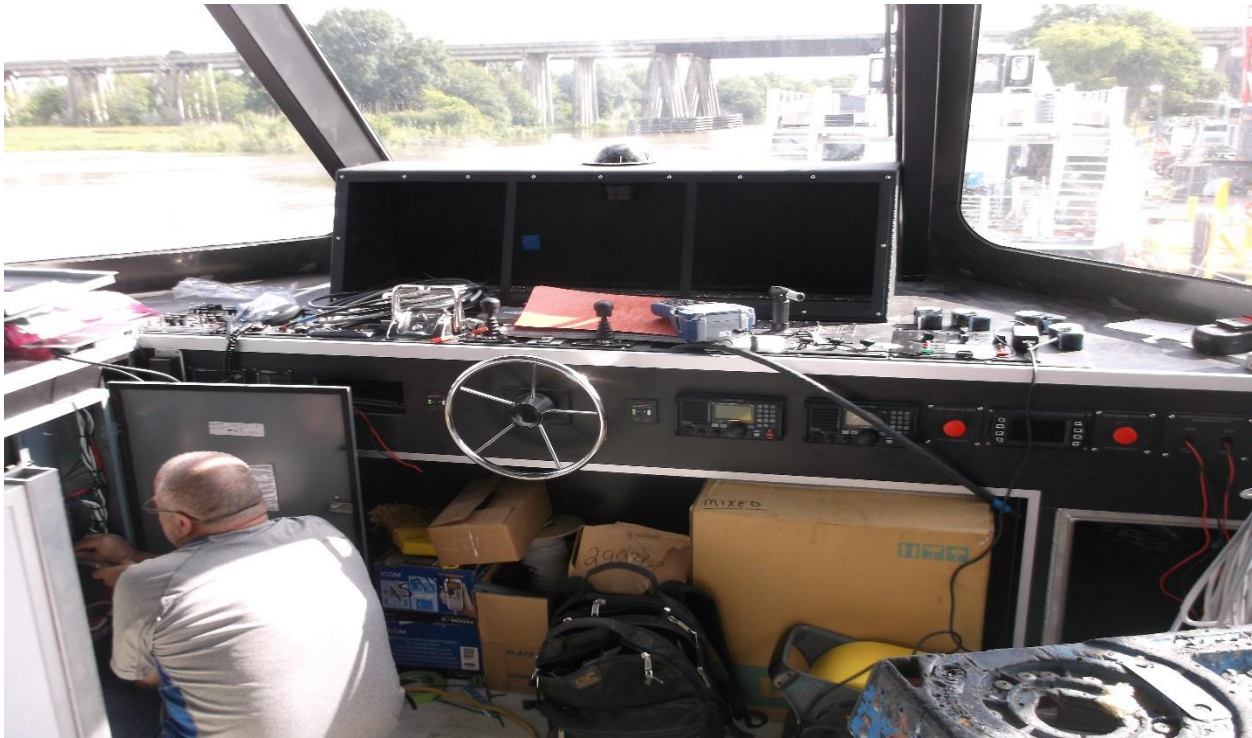
View inside pilothouse with most of components installed and wiring connections working everywhere

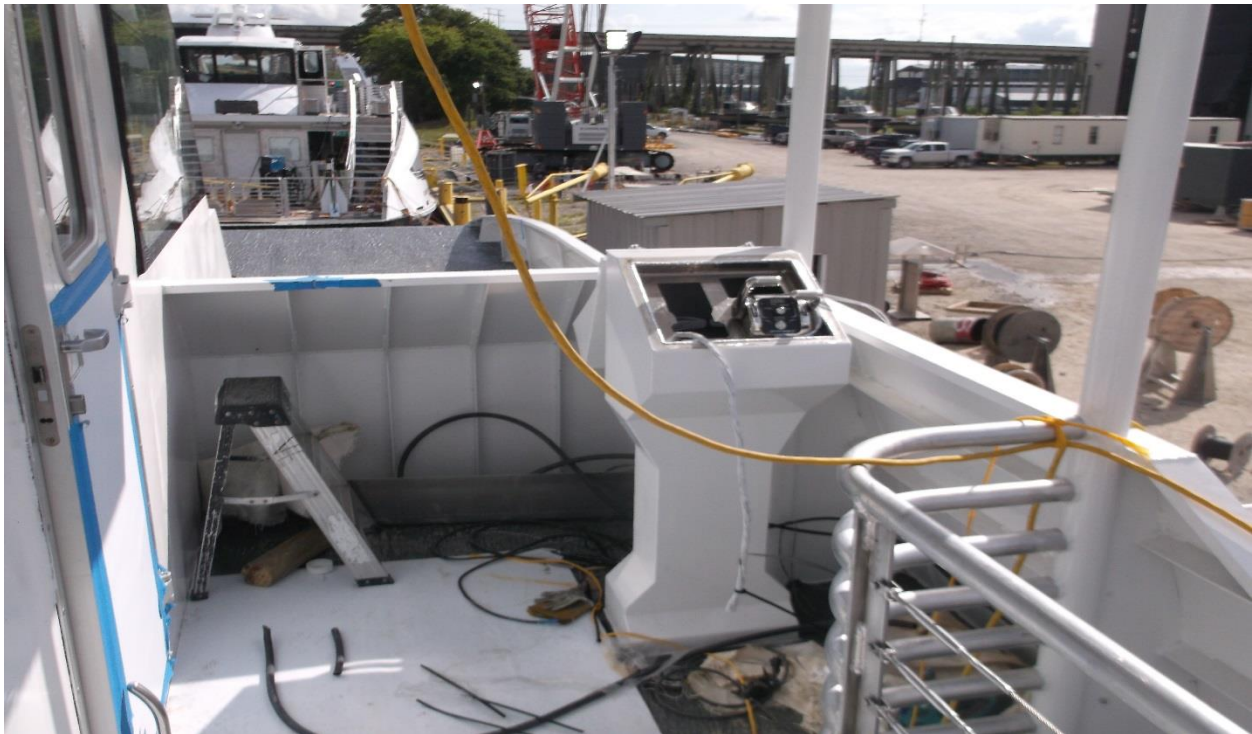
View of starboard side wing control station working with main engine controls installed

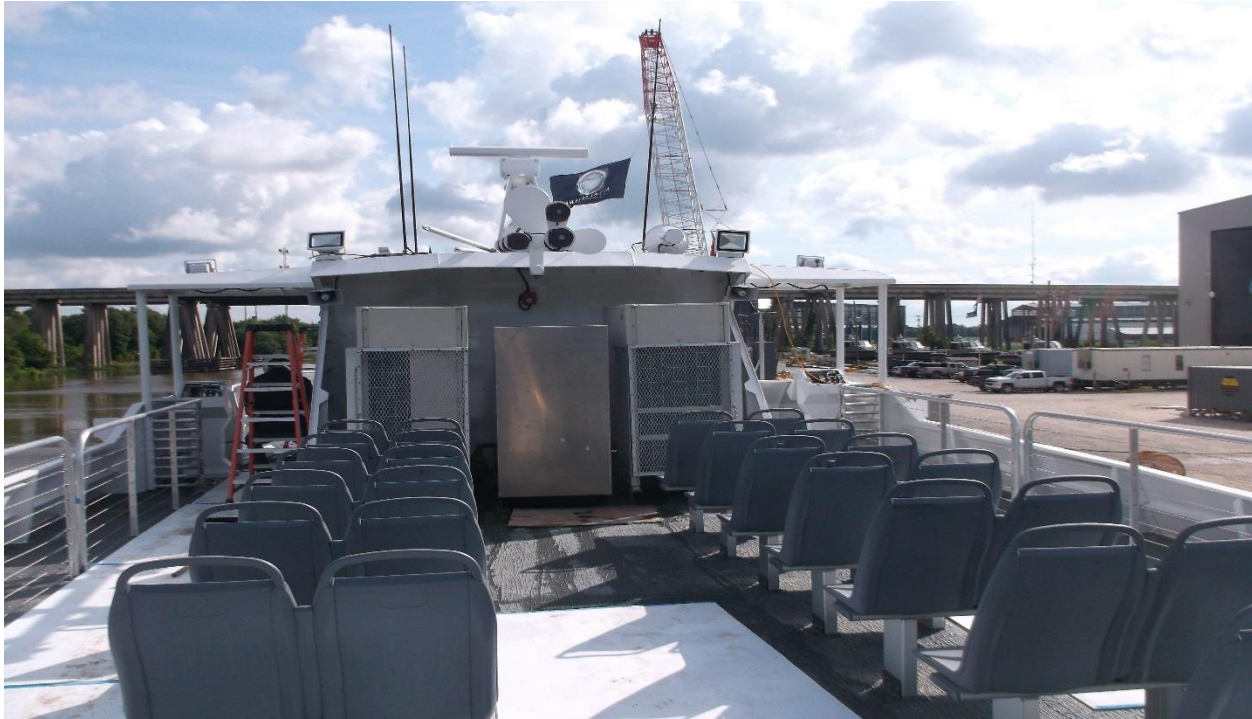
Overall view of upper deck from aft end
